ADDENDUM #1
BID DOCUMENTS
1453 JEFFERSON AVENUE, DEXTER'S PHARMACY
BUFFALO, NY 14208

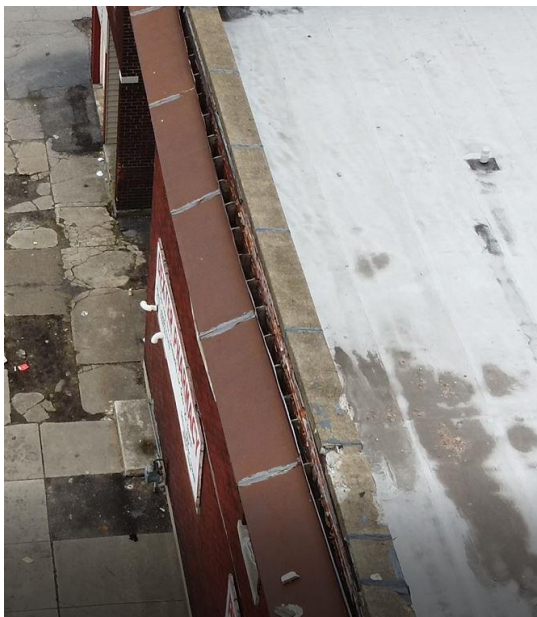
As the notes on the drawings are not particularly specific some further detail should be helpful, however, the exact extent can only be determined during construction. On the north (Ferry Avenue) elevation there is a section of the cornice which is bowing down. Looking back at the.

Drone footage of north cornice problem

photos from last year this bow was evident then, but is perhaps more pronounced now. The drone footage shows that some framing is still attached to the wall, but it is unclear whether there is any rot to the framing members. This will have to be further investigated in the field. It may be as simple as pulling everything back in line and securing the metal roof and cornice profile, or it may require replacing some framing and then reattaching the metal sections. The underlying structure of the cornice in this area likely needs reinforcement or replacement. Therefore, figure 35 lineal feet of such repair. The flashing for the most part looks in decent condition, but should also be investigated during construction, as the one note instructs. At the bowed area the flashing obviously will need to be reset into a mortar joint above since it has pulled away. This should be done with a reglet set into the joint and 50 year silicone caulk. At this time repair and painting with rustproof paint is mentioned by the existing note, but the extent of repair may be more extensive than previously known. The roof of the cornice on the west elevation shows that certain sections of the roof have been replaced (see photo). Whether or not this previous repair is adequate or not will have to be investigated up close. The top of the replaced sheet metal is standing free of the wall, so this must be fixed so that either it, or additional flashing on top of it, is set into the mortar joint. A reglet with 50 year silicone caulk should be used at all flashing where it is set into the brickwork. Since the note on the drawings says repair as required this should be included in the bid.

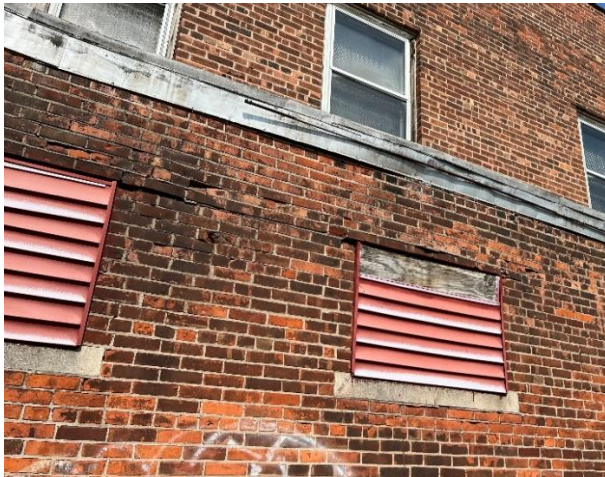
Figure 1

The south elevation of the building has areas that were not included in the original drawing set due to budgetary concerns. These areas show displaced brickwork and missing mortar, as a result of delamination of the steel brick angle lintels over the openings. Repairing these areas should be figured as an alternate (alternate #3, the first two alternates are listed on Sheet A-1)).

Figure replacing the steel lintels over 3 of the 5 first floor window openings and rebuilding the brickwork around the opening where it is displaced (see Figure 1). New 3 1/2" x 3 1/2" x 5/16" galvanized steel lintels shall be installed here and on the second floor at the triple window and the single window immediately to its left (Figure 2).
