ADDENDUM #1
BID DOCUMENTS
1453 JEFFERSON AVENUE, DEXTER'S PHARMACY
BUFFALO, NY 14208

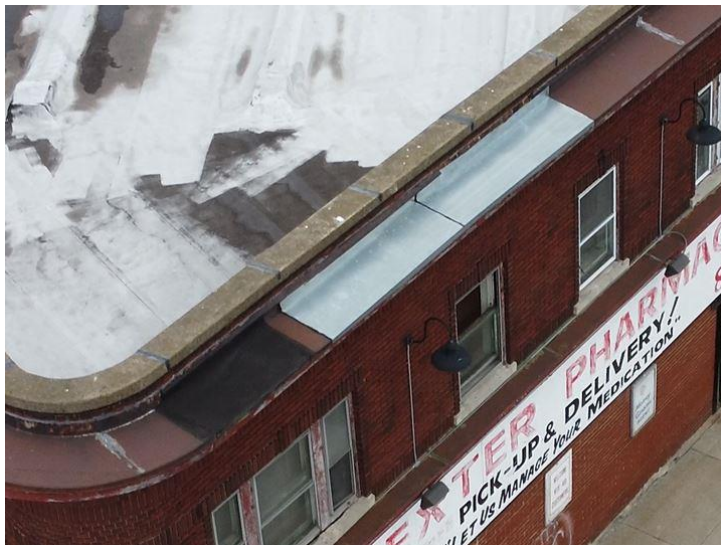
As the notes on the drawings are not particularly specific some further detail should be helpful, however, the exact extent can only be determined during construction. On the north (Ferry Avenue) elevation there is a section of the cornice which is bowing down. Looking back at the.

photos from last year this bow was evident then, but is perhaps more pronounced now. The drone footage shows that some framing is still attached to the wall, but it is unclear whether there is any rot to the framing members. This will have to be further investigated in the field. It may be as simple as pulling everything back in line and securing the metal roof and cornice profile, or it may require replacing some framing and then reattaching the metal sections. The underlying structure of the cornice in this area likely needs reinforcement or replacement. Therefore, figure 35 lineal feet of such repair. The flashing for the most part looks in decent condition, but should also be investigated during construction, as the one note instructs. At the bowed area the flashing obviously will need to be reset into a mortar joint above since it has pulled away. This should be done with a reglet set into the joint and 50 year silicone caulk. At this time repair and painting with rustproof paint is mentioned by the existing note, but the extent of repair may be more extensive than previously known. The roof of the cornice on the west elevation shows that certain sections of the roof have been replaced (see photo). Whether or not this previous repair is adequate or not will have to be investigated up close. The top of the replaced sheet metal is standing free of the wall, so this must be fixed so that either it, or additional flashing on top of it, is set into the mortar joint. A reglet with 50 year silicone caulk should be used at all flashing where it is set into the brickwork. Since the note on the drawings says repair as required this should be included in the bid.
